The Fence around Sharphill Wood

This report documents the state of the post and rail fence 'encircling' Sharphill Wood, installed in the summer of 2018, as it was found to be on 10-11 November 2023, with an update added to the first row of the table below on 28 January 2024.

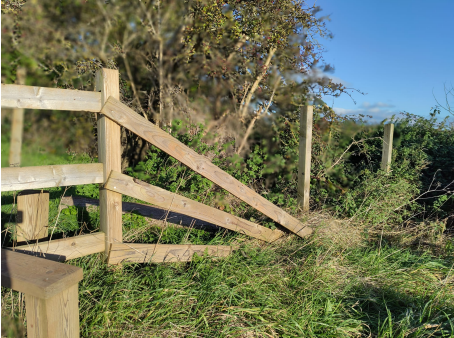
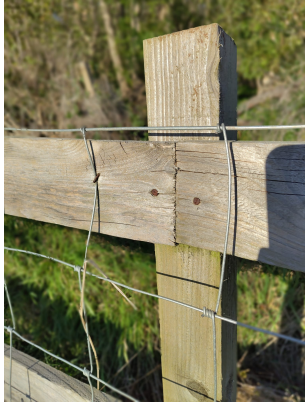
Grid Ref	Notes	Damage	Nails
SK5853 3457	Stile and dog entrance erected Spring 2022.	Fence around the stile and dog entrance destroyed by vandals April 2022.

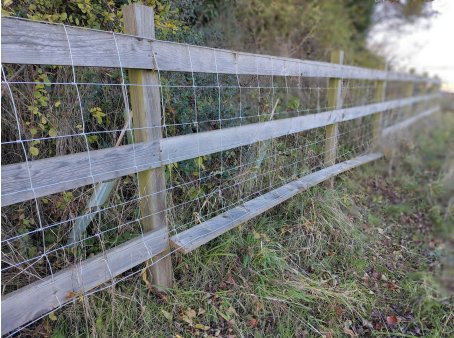
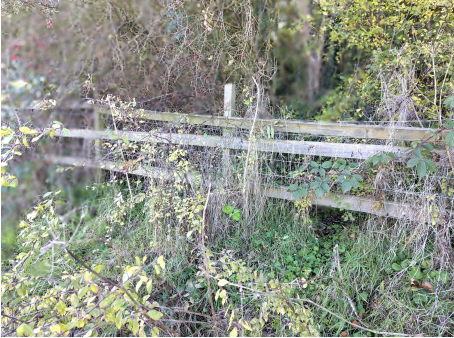
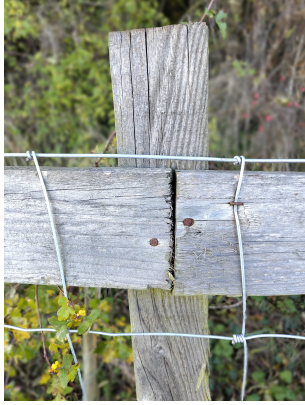
No fence between above point and the "Wheatcroft" entrance at SK58673461 (Point 5 on map) with the exception of a small (intact) section at the "Kissing Gate" Entrance SK58593451 (Point 4 on map)		
SK58673462 SK58713469	Between "Wheatcroft entrance" and Multi Use Games Area	Two instances of rails which are detached

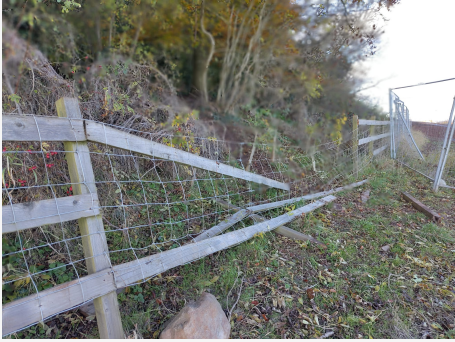
Grid Ref	Notes	Damage	Nails
SK58763478	Adjacent to temporary fencing along MUGA construction site	Destruction of fence/vandalism

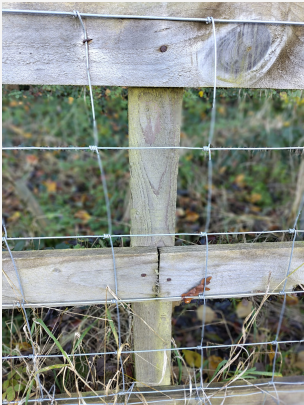
Between SK58763478 and SK58763488	Temporary metal fence erected during construction of the MUGA	Wholesale destruction of plantings made in the winter of 2018/19. This section will need strong, substantial fencing to a suitable height due to the likelihood of ball games in the vicinity and also pressure from MUGA users to access the wood where there is no entrance.	
SK58763490

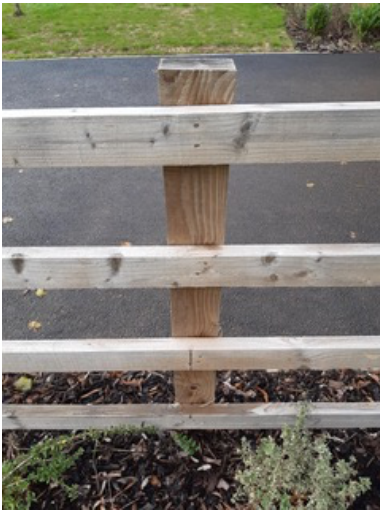
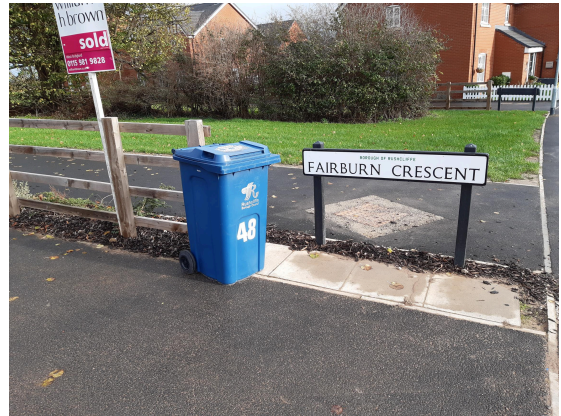
As a point of comparison and reference, the photographs below show a section of the post and rail fence on the main Melton Road, Edwalton Housing development (at Fairburn Crescent).

Here, the same Developer(s) has constructed similar, but much more substantial, fencing; this is characteristic of the fencing constructed elsewhere on the housing estate, which remains in good condition. It can be seen from the photographs that the rails are double nailed to the posts, and the timber is much more substantial than that used around Sharphill Wood.
