The Fence around Sharphill Wood

This report documents the state of the post and rail fence 'encircling' Sharphill Wood, installed in the summer of 2018, as it was found to be on 10-11 November 2023, with an update added to the first row of the table below on 28 January 2024.

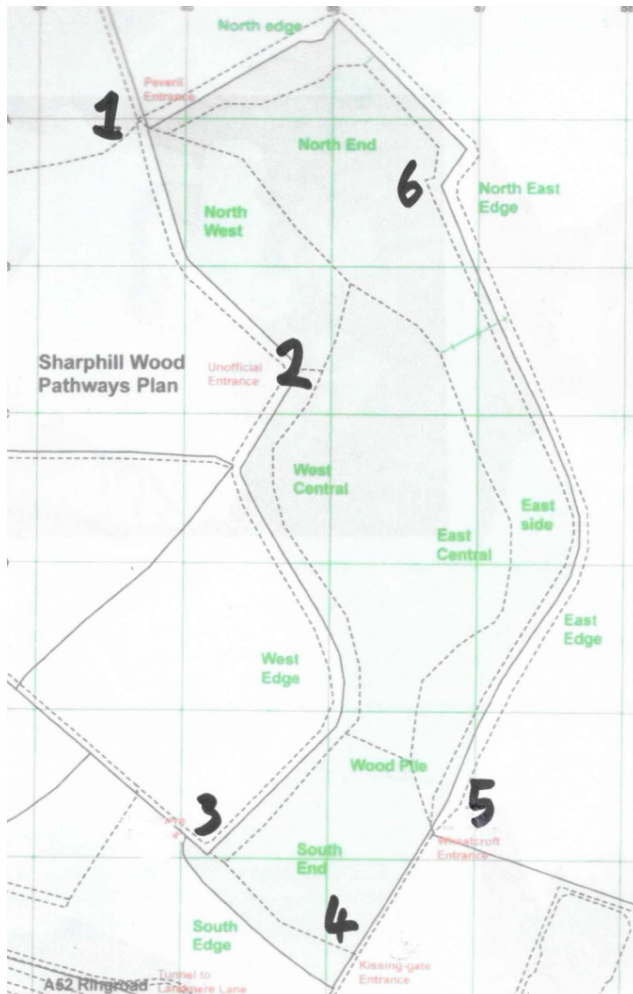
Although some sections of the fence are still in good repair, in many places the rails have come away because they were poorly attached to the posts. Also many posts are now unstable or have come out of the ground altogether, presumably due to rotting of the sections that are in the ground.

Whilst examining the fence many photos of the fixings were taken and these are presented alongside the Grid References. Over 99% used a single-nail method. In fact during the tour of the fence only 19 instances were observed where a double-nail method was employed. These were at corner sections of the fence and at the newer section of fence beside point 2.
